**The Effect of Surface Defects
of HeroShaper Rotary Instruments
on the Cyclic Fatigue Fracture:
A Fractographic Analysis**

**The Graduate School
Yonsei University
Department of Dentistry**

A Master's Thesis

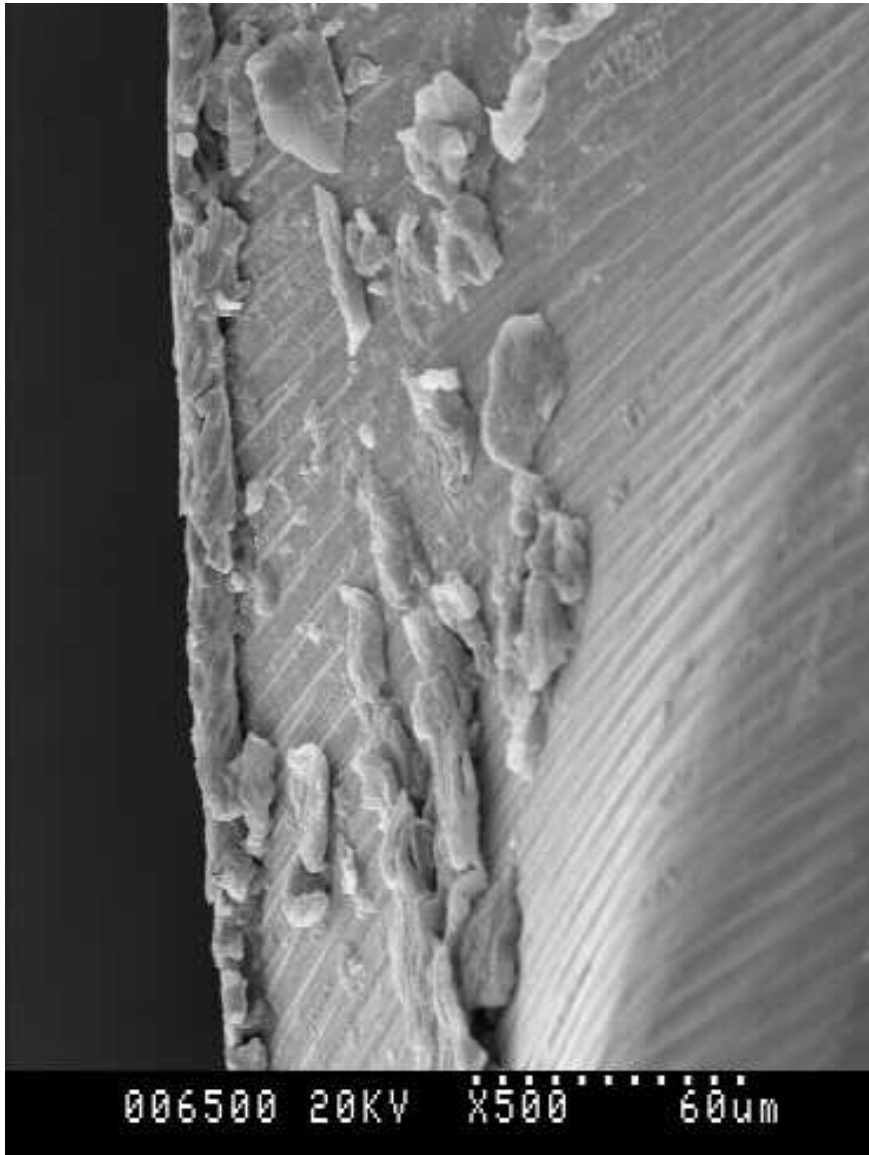
Figure 2

Microphotographs of the lateral surface of the HeroShaper files show metal rollover (Fig. 2) and significant machining marks along the faces of the flutes (Fig. 3). In contrast, the lateral surface of the new file was clean and flawless (Fig. 4).

Figure 2. Low magnification SEM image of the surface of a HeroShaper file in Group 2, showing metal rollover (original magnification, $\times 500$).

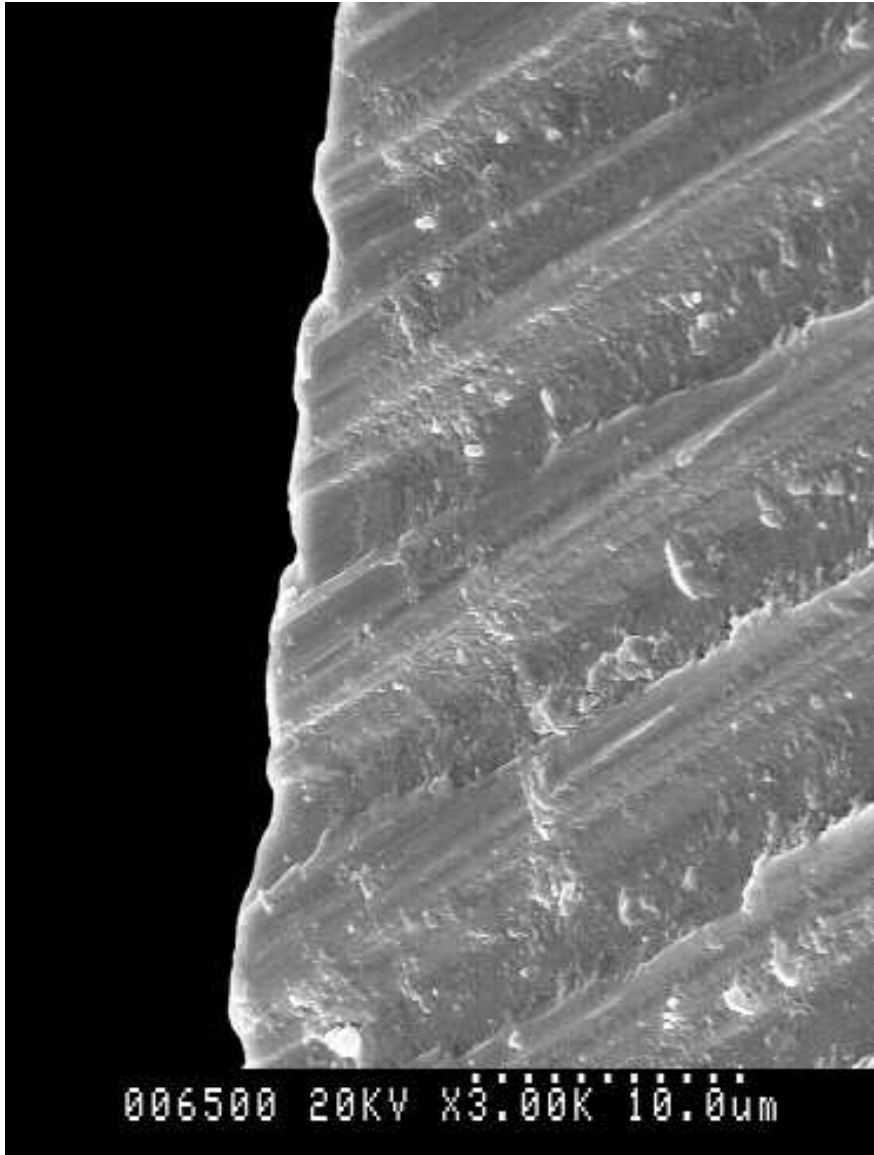
Figure 3

Figure 3. High magnification SEM image of the surface of a HeroShaper file in Group 2, showing significant machining marks along the faces of the flutes associated with the manufacturing process (original magnification, $\times 3000$).

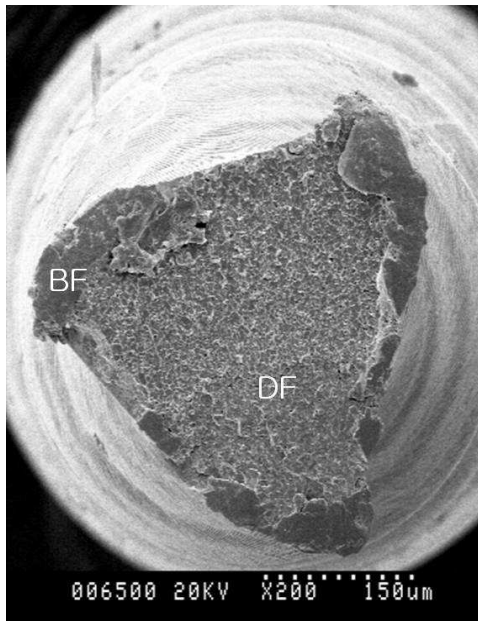
Figure 5 (a)

Figure 5 shows a typical example of a fractured surface of a HeroShaper instrument that occurred during cyclic bending. A low-magnification ($\times 200$)

SEM photomicrograph shows brittle fracture to be the main failure mode initially, which typically led to a region of catastrophic ductile fracture. There was a transition from brittle fracture to ductile fracture in all cases. Qualitatively, the ductile failure region in all the files constituted a larger portion of the surface area and was characterized by microvoid formation and dimpling (cup-and-cone fracture) (Fig. 5 (b)).

Figure 5. SEM image of a fractured surface of a HeroShaper file in Group 1. A region of brittle fracture (BF) is shown originating from the machining groove and subsurface damage. The brittle fracture region transforms to catastrophic ductile failure (DF) (a). A high magnification view of the fractured surface of the same file shows elongated dimples (cup-and-cone fracture) that are indicative of ductile fracture. This characteristic feature of ductile failure results from microvoid coalescence as the instrument is subjected to stress (b) (original magnification, (a) $\times 200$, (b) $\times 3,000$).

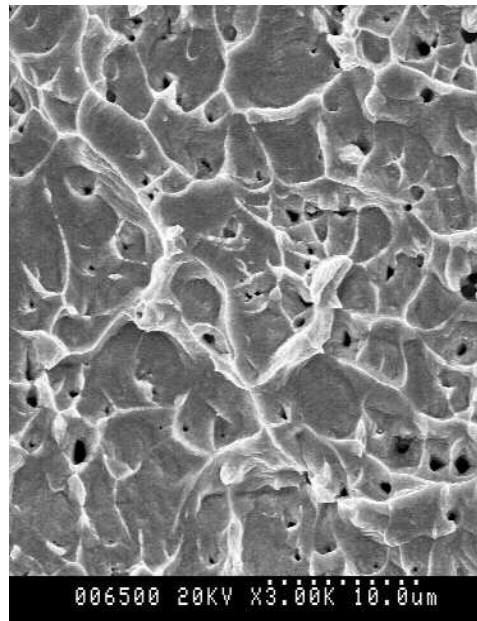
Figure 5 (b)

It is evident that the large number of NiTi rotary instruments observed by SEM showed a variety of fracture processes during clinical separation (Fig. 2-9). The fractured HeroShaper instruments generally displayed dimpled rupture features, as shown in Figure 5 (b). These dimples, which were indicative of ductile fracture, were also generally observed on the fracture surfaces of other instruments such as ProFile, ProFile GT, ProTaper etc (14).

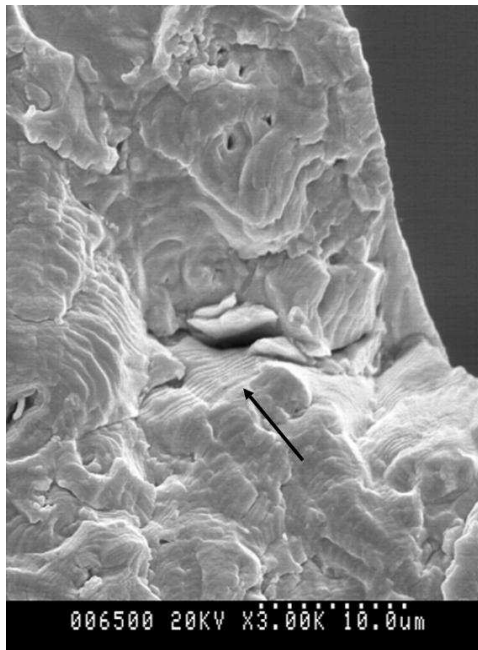
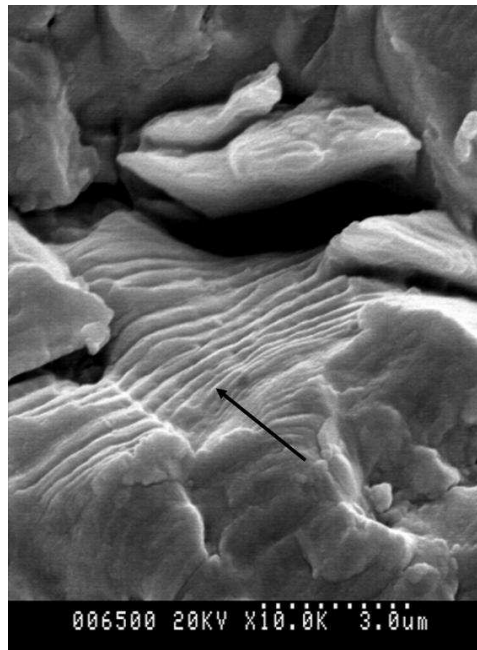
At higher magnification ($\times 3000, 10,000$), the brittle fracture region often showed fatigue striations and a large number of secondary cracks (Fig. 6 (a), (b)). This suggests that there were three characteristic stages of fatigue crack growth: Stage I (initiation), Stage II (propagation), and Stage III (catastrophic failure). Stage I always involves the base of a machining groove and is recognizable pre-existing machining damage (Fig. 7). The distinct zone of ductile dimpling occurs in Stage III. Figure 8 shows the brittle fracture region and the transition to ductile failure more clearly.

Figure 6. High magnification SEM images of the brittle fracture region, showing fatigue striations (arrows) and numerous secondary cracks (original magnification, (a) $\times 3,000$, (b) $\times 10,000$).

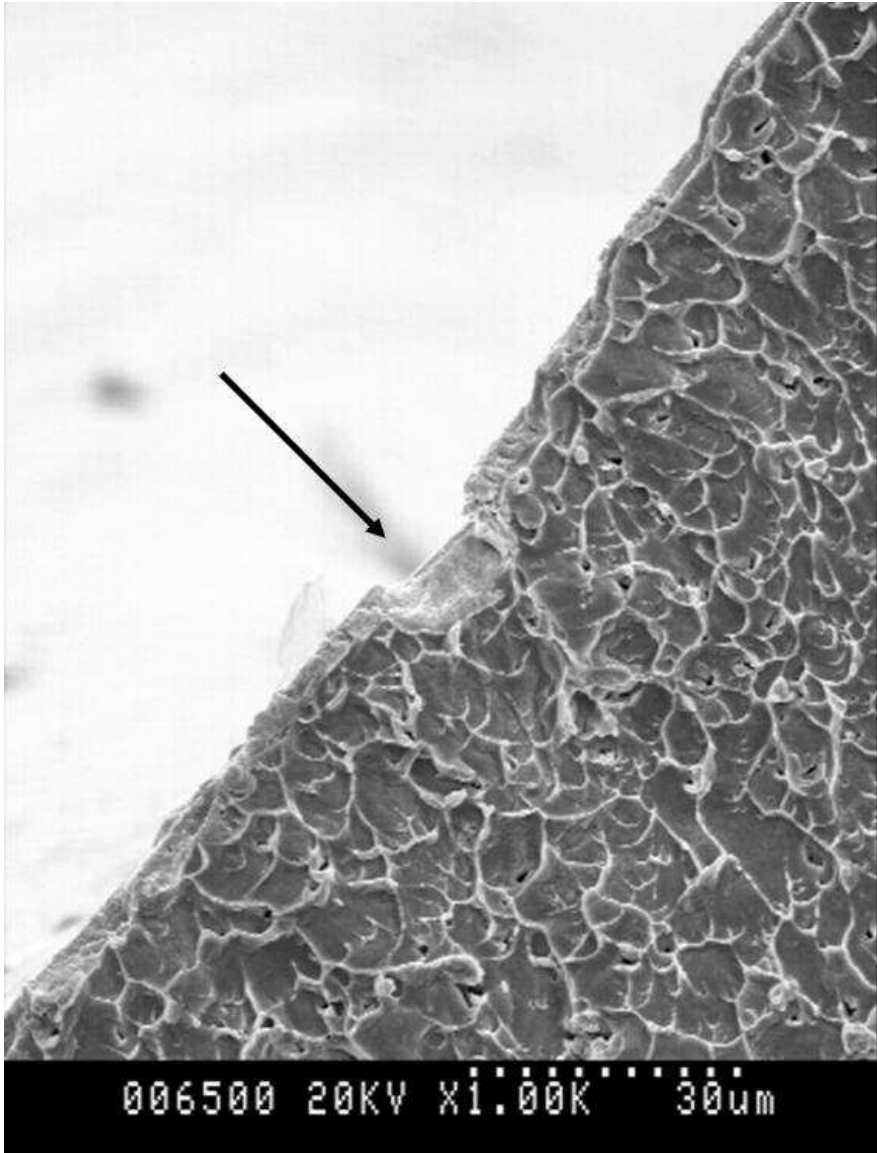
Figure 7

The fractographic features of the clinically fractured instruments in this study are consistent with crack propagation (in a brittle fracture mode) from pre-existing machining damage, which transforms to catastrophic ductile failure. This suggests that many premature fractures of NiTi rotary instruments occur (possibly within the elastic limit of the instrument) as a result of crack growth from manufacturing defects.

Figure 7. SEM image showing recognizable pre-existing machining damage (arrow) (original magnification, $\times 1,000$).

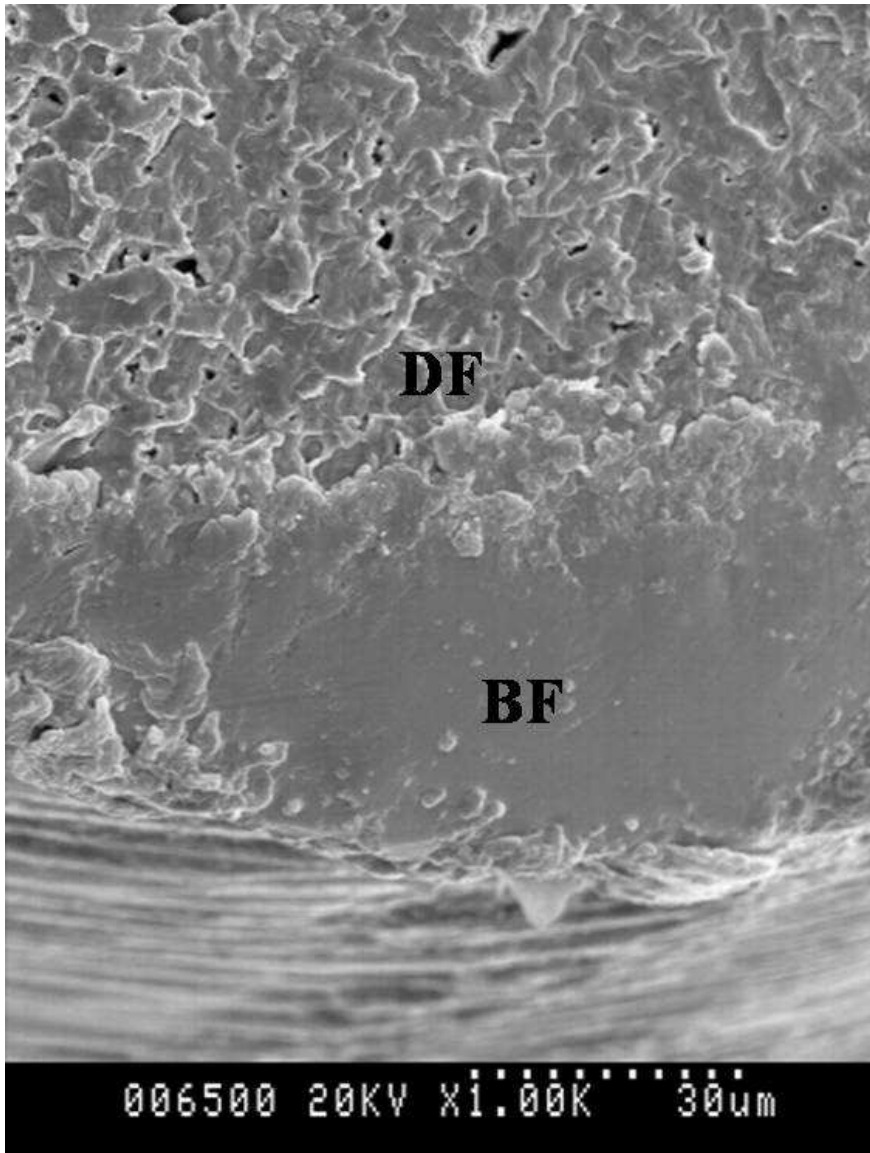
Figure 8

Figure 8. SEM image of the brittle region (BF) and the transition to a ductile failure region (original magnification, $\times 1,000$).

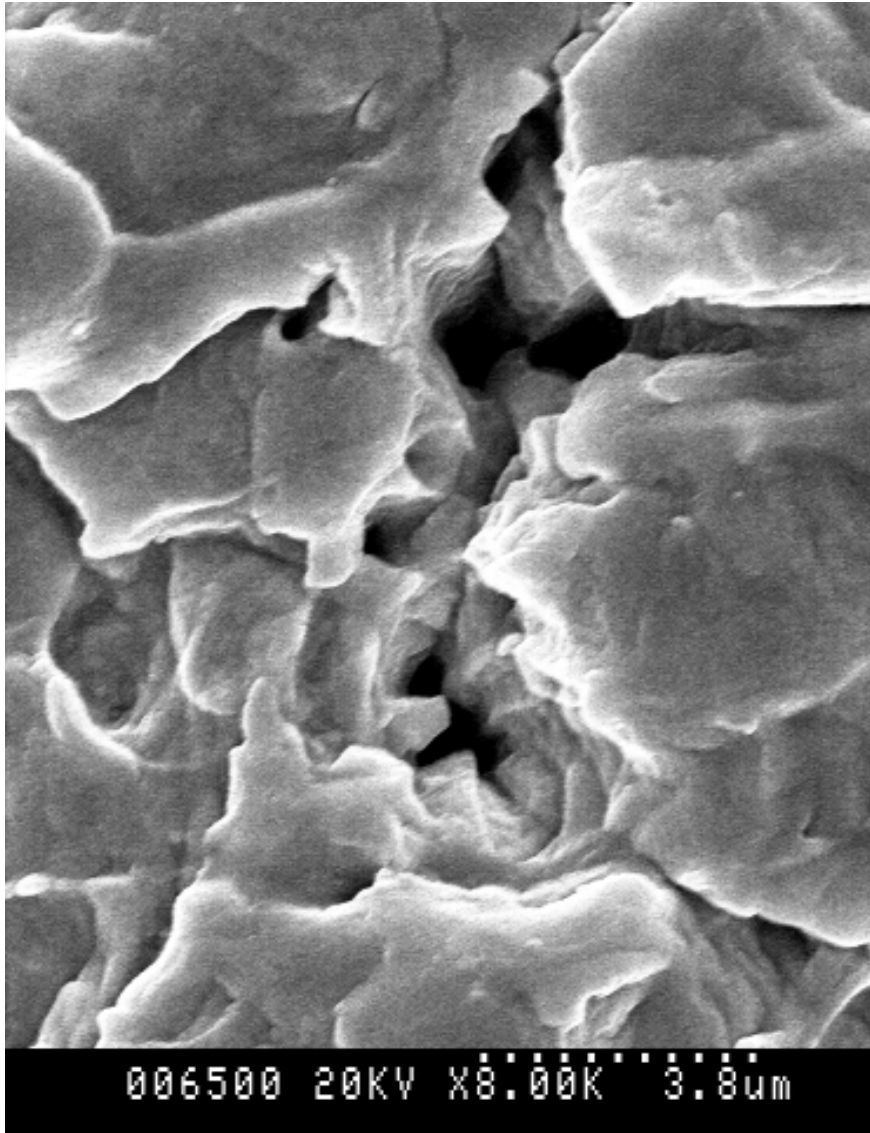
Figure 9

Typically, the fractured file surface in group 3 showed evidence of transgranular (cleavage) fracture across the grains (Fig. 9), as well as intergranular fracture along the grain boundaries (Fig. 10). Voids or regions of separation between some of the grains were also evident in Figure 9. This suggests the loss of small grains, subgrains, or secondary phase particles during the fracture. Although these types of fractured surfaces correspond to a ductile fracture process, it is distinctively different from the type of fracture shown in Figure 5 (b).

Figure 9. SEM image of a fractured face of a HeroShaper file in Group 3, showing evidence of transgranular (cleavage) fracture across the grains (original magnification, $\times 8,000$).

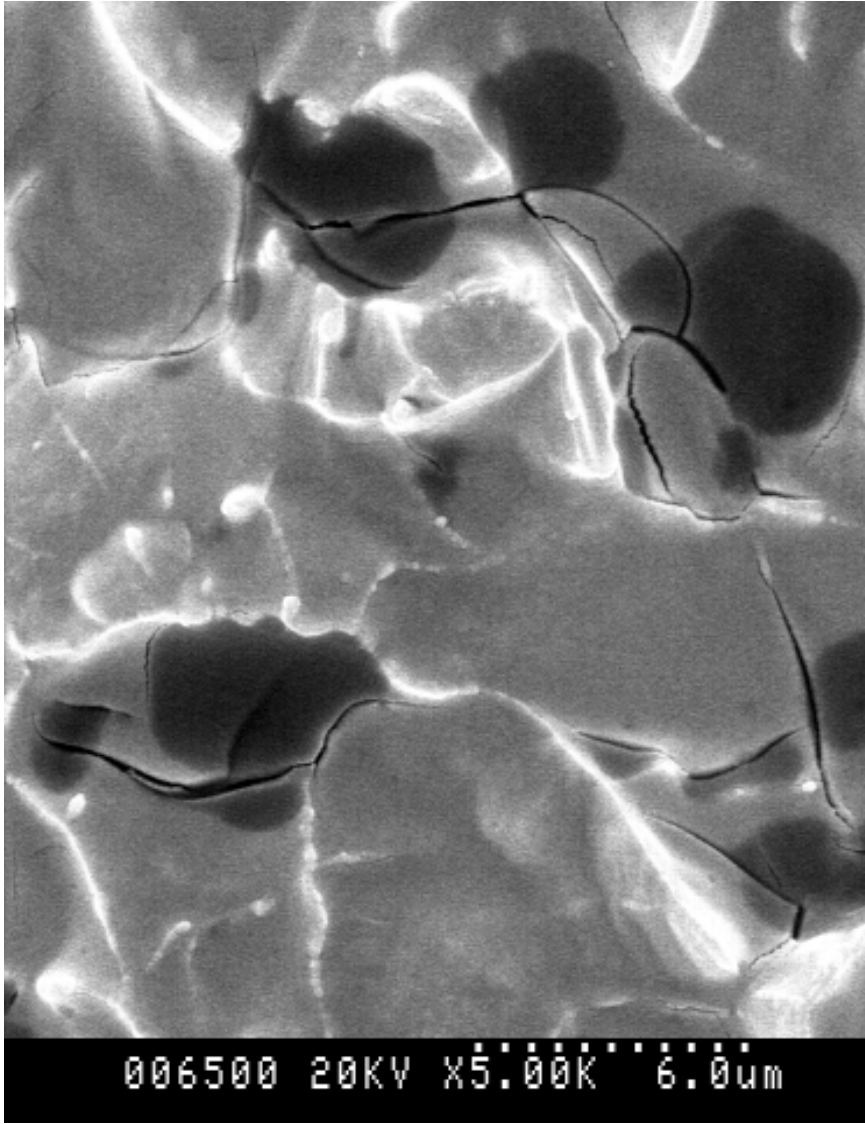
Figure 10

Figure 10. SEM of fractured face of a HeroShaper file in Group 3, showing evidence of intergranular fracture along the grain boundaries (original magnification, $\times 5,000$).
