## The Effect of Surface Defects on the Cyclic Fatigue Fracture of HEROShaper Ni-Ti rotary files in a Dynamic Model: A Fractographic Analysis

Jung-Kyu Lee<sup>1</sup>, Eui-Sung Kim<sup>1</sup>, Myoung-Whai Kang<sup>2</sup>, Kee-Yeon Kum<sup>2\*</sup>

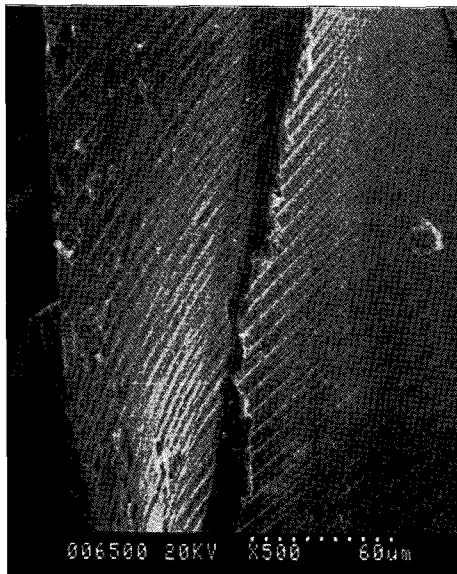
Microphotographs of the lateral surface of HEROShapers in group 2 showed metal rollover and/or significant machining marks along the faces of the flutes (Figure 2). In contrast, the lateral surfaces of the new HEROShaper files were rather clean and flawless. The low-magnification

**Figure 2.** Photomicrograph of a HEROShaper instrument in group 2 (before fatigue testing) showing the presence of manufacturing defects such as metal roll-over and machining marks (original magnification,  $\times 500$ ).

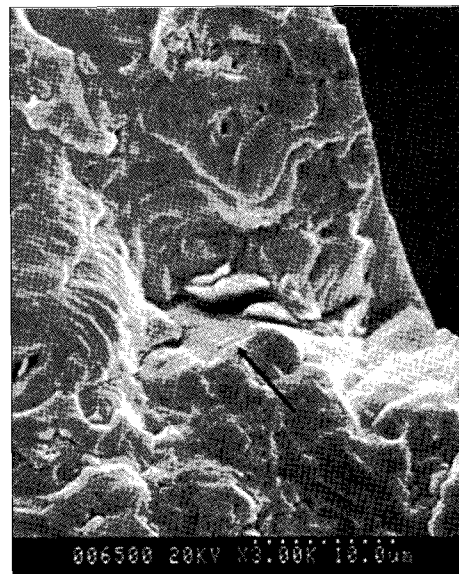
**Figure 3.** High magnification the SEM image of the brittle fracture region showing clusters of fatigue striations (arrows) as well as numerous secondary cracks (original magnification ( $\times 3000$ )).

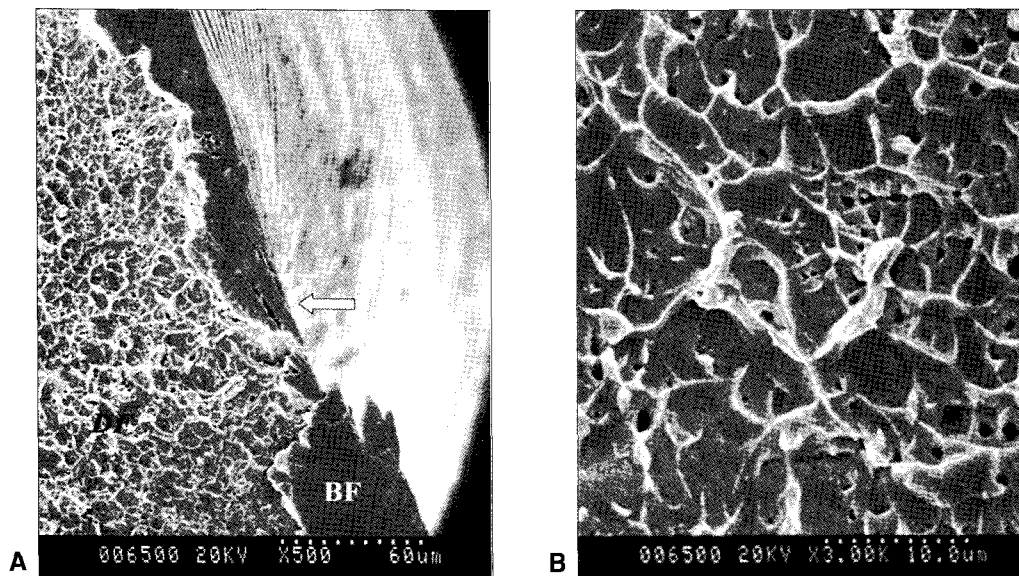
( $\times 200$  and  $\times 500$ ) SEM images show small areas of brittle fracture located on the edge of the cross section of the fractured instruments, which typically leads to a large central fibrous area of catastrophic ductile fracture. The higher magnification view ( $\times 3000$  and  $\times 10,000$ ) revealed clusters of fatigue striations and a large number of secondary cracks in the brittle fracture area (Figure 3), which confirmed that the instruments failed as a result of fatigue. Transgranular fracture across the grains as well as intergranular fracture along the grain boundaries was also observed in the brittle fracture area. The ductile fracture area was characterized by the typical formation of microvoids and the dimpling (cup-and-cone fracture), particularly elongated dimples in some specimens in group 3 (Figure 4a). All the fractured surfaces of HEROShapers in groups 2 and 3 were always consistent with the slow crack propagation (in a brittle fracture mode) from pre-existing surface defects (Figure 4b). Voids or regions of separation between some grains are also evident.

**Figure 4.** SEM image of the fractured surface of a HEROShaper instrument in Group 2. The brittle fracture (BF) region is shown originating from a microcrack. The brittle fracture region transforms to catastrophic ductile failure (DF) (a, original magnification,  $\times 200$ ). A high magnification view of the fractured surface of the same file shows elongated dimples (cup-and-cone fracture) that are indicative of ductile fracture. This characteristic feature of ductile failure results from microvoid coalescence as the instrument is subjected to stress (b, original magnification,  $\times 3000$ ).
