**The Effect of Surface Defects
of HeroShaper Rotary Instruments
on the Cyclic Fatigue Fracture:
A Fractographic Analysis**

**The Graduate School
Yonsei University
Department of Dentistry**

A Master's Thesis

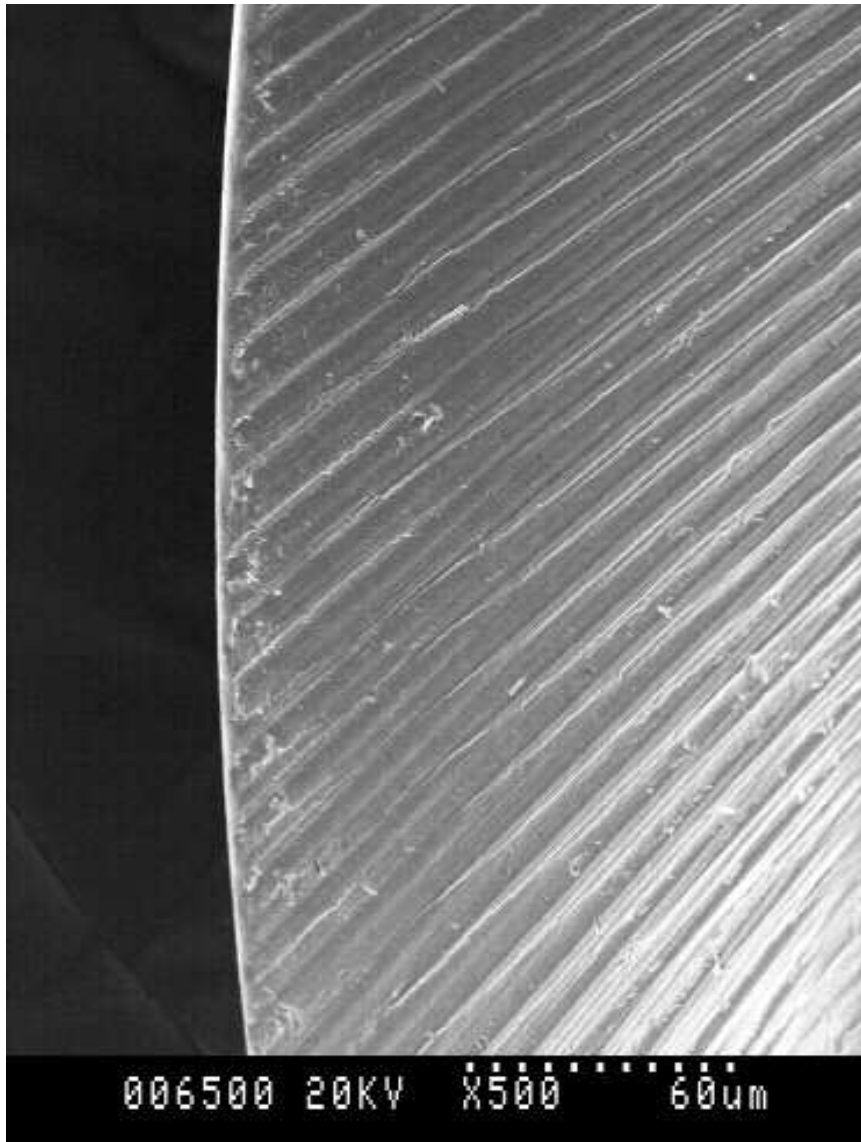
Figure 4

Microphotographs of the lateral surface of the HeroShaper files show metal rollover (Fig. 2) and significant machining marks along the faces of the flutes (Fig. 3). In contrast, the lateral surface of the new file was clean and flawless (Fig. 4).

Figure 4. SEM image of a new HeroShaper file surface, showing a clean and flawless surface (original magnification, $\times 500$).
