False Femoral Neck Fracture Detected during Shaft Nailing: A Mach Band Effect

Departments of ¹Orthopaedic Surgery and ²Radiology, Gangnam Severance Hospital, Yonsei University College of Medicine, Seoul, Korea.

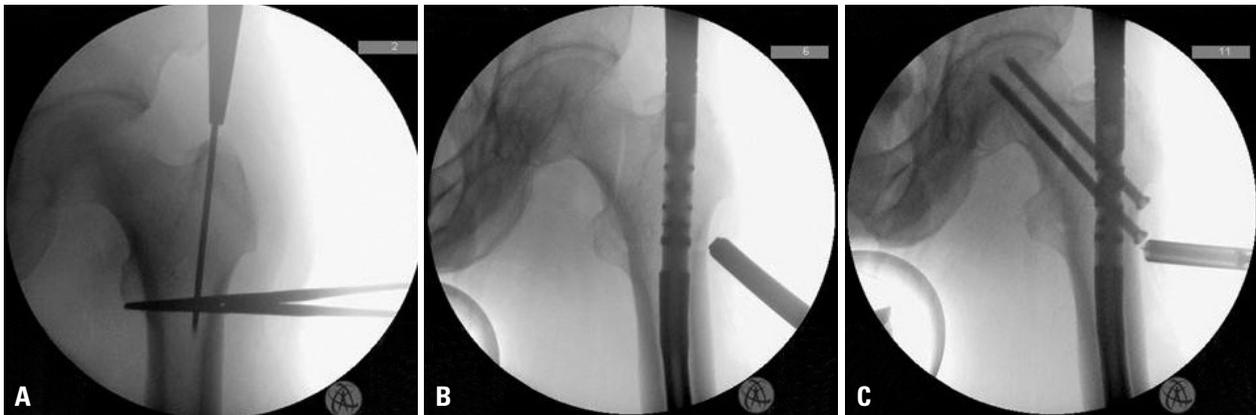
Fig. 1. (A) A 3.2-mm guide pin was inserted at the tip of the greater trochanter; the radiolucent line was not visible at that time. Hemostatic forceps were used to control the external rotation of the proximal fragment.⁴ (B) A radiolucent line mimicking a femoral neck fracture was visible after nail insertion. (C) A reconstruction nail was inserted for fixation of the femoral neck and shaft fracture; the radiolucent line appeared to decrease in size after insertion of two 6.0-mm partially threaded cancellous screws into the femoral neck and head.

after femoral neck screw fixation; however, we realize that rotation of the limb was different. The lesser trochanter was more prominent in the post-fixation image. We suspect a tiny difference in limb rotation caused the decrease in pseudofracture gap on the fluoroscopic image.⁵ In conclusion, we recommend that surgeons check the fracture line again in the reversed fluoroscopic image (tracing the adjacent fat plane and its connectivity with the fracture line) before converting to reconstructive nailing. However, if the presence of a pseudofracture cannot be definitively ascertained, then antegrade femoral nailing must be converted to reconstructive nailing or another method of fixation. Additionally, all supporting fluoroscopic images should be saved for further evaluation and documentation.

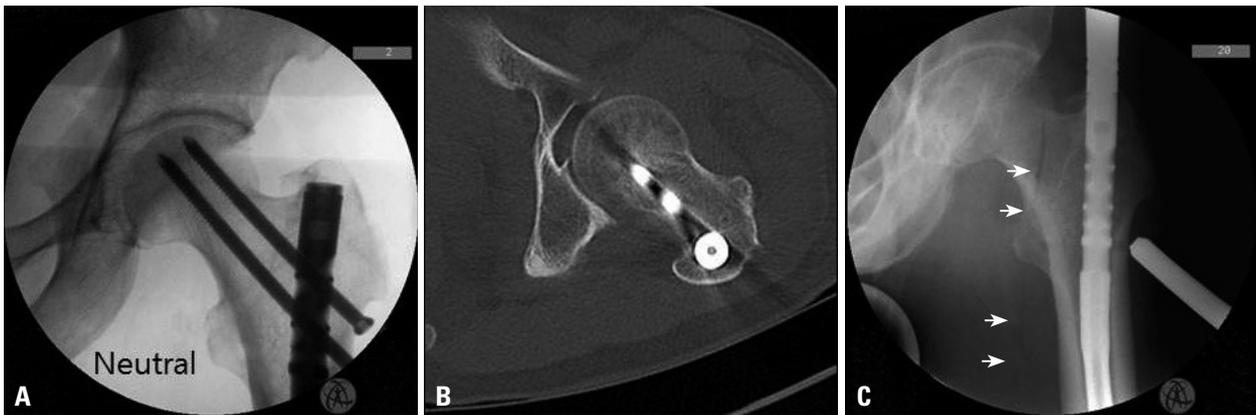
Fig. 2. (A) Postoperative fluoroscopic study failed to reveal the femoral neck fracture in various limb rotations. (B) A CT scan confirmed that the femoral neck was intact. (C) Reversal of the fluoroscopic image taken in the operating room showed a radiolucent line running from the femoral neck to the medial thigh (arrows).

days after surgery, we took a CT scan of the proximal femur in order to analyze the radiolucent line observed during intraoperative fluoroscopy; the femoral neck was confirmed as intact. Reversal of the fluoroscopic image taken in the operating room showed a radiolucent line running from the femoral neck to the medial thigh (Fig. 2).
