Effect of Various Surface Treatments on the Repair Bond Strength of Nanofilled Composite to Composite

Yonsei University

A Master's Thesis Submitted to the Department of Dentistry And the Graduate School of Yonsei University In partial fulfillment of the Requirements for the degree of Master of Dental Science

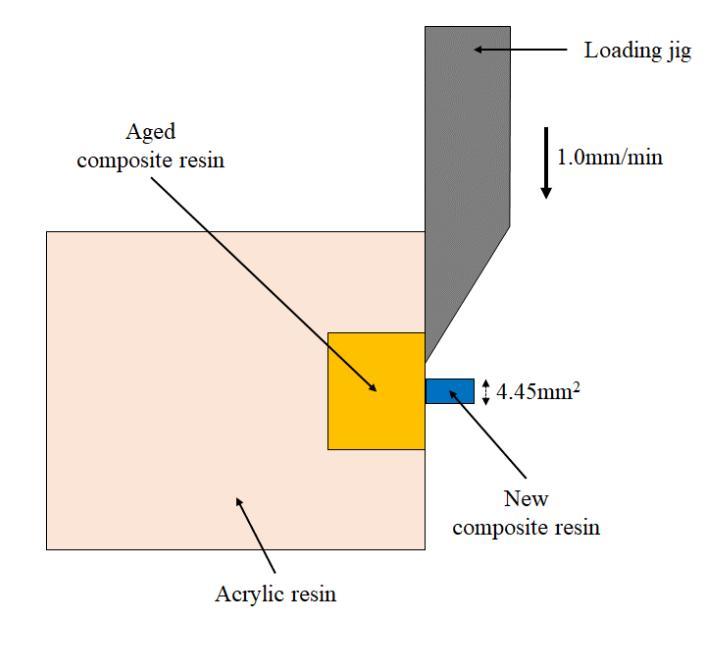
Shear bond strength (MPa) = $\frac{\text{Maximum load (N)}}{\text{Bonded surface (mm^2)}}$

Figure 1. Scheme of the shear bond strength test.

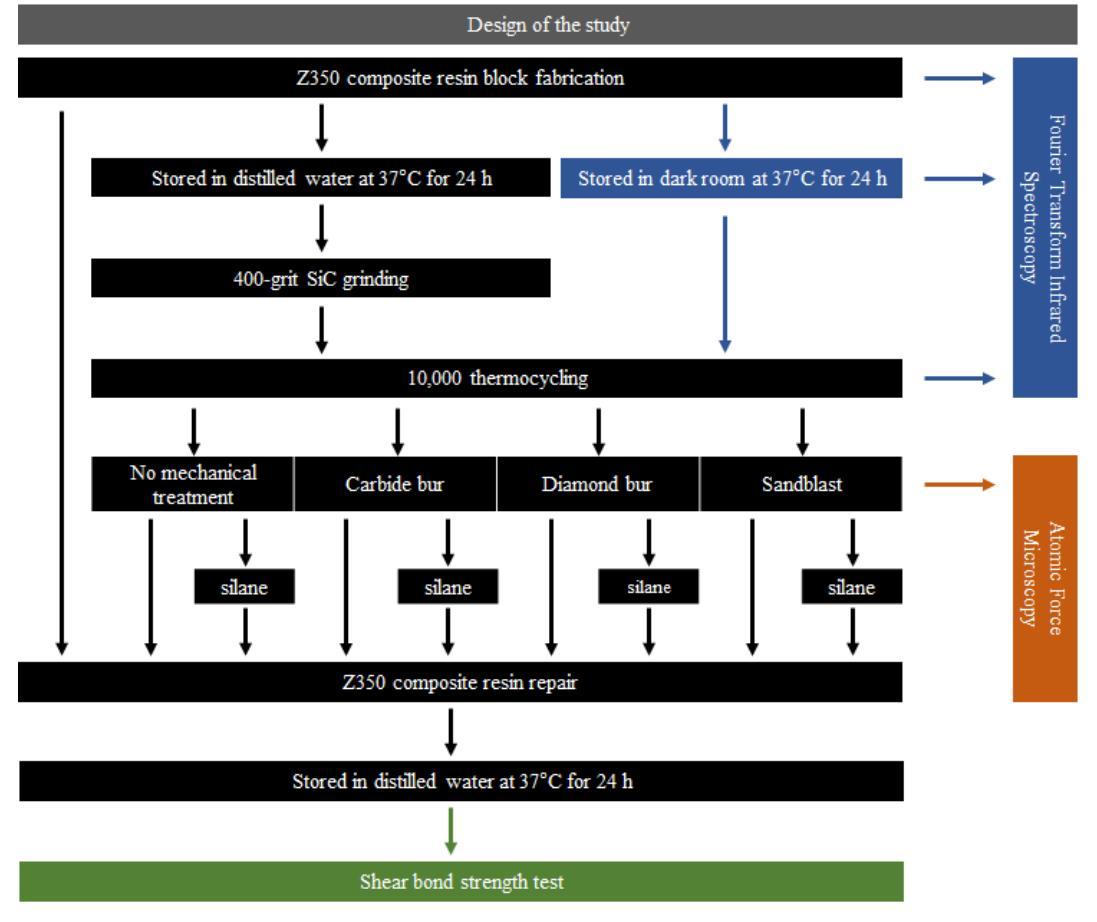
Figure 2. Schematic study design of SBS, FTIR, and AFM

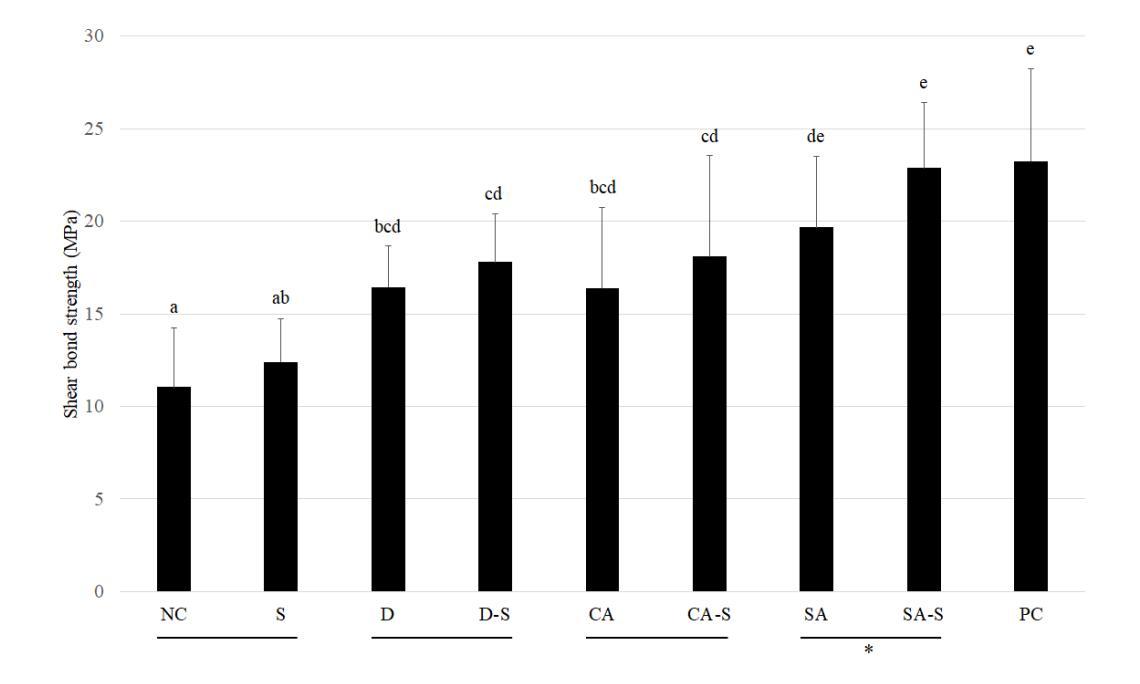
The results are presented in Table 3 and Figure 3. Group SA-S exhibited the highest average bond strength, whereas group S showed the lowest average bond strength. The results of the one-way ANOVA indicated a significant difference between group SA-S and all other mechanically treated groups (p < 0.05). Groups SA-S and SA were the only ones comparable to the positive control (PC) group. Furthermore, significant differences were observed between all mechanically treated groups and the negative control (NC) group. Based on the independent t-test results, an additional silane application resulted in an increase in the bond strength within the same mechanically treated group. However, the difference was statistically significant only within the sandblasted group (p < 0.05).

Figure 3. Means and standard deviations of the shear bond strength (MPa). Different lowercase letters indicate a statistical difference (p < 0.05). Columns above the same horizontal line indicate no significant differences within each mechanically treated group, while * indicates a significant difference (p < 0.05).

To improve micro-mechanical retention, and consequently, repair bond strength, various surface treatments were performed. Results presented in Table 3 and Figure 3 demonstrate that various surface treatments significantly influenced repair bond strength. In the absence of surface treatment (group NC), the shear bond strength and surface roughness exhibited the lowest values. SEM analysis further validated these results, showing only minor changes in surface topography. These findings emphasize the

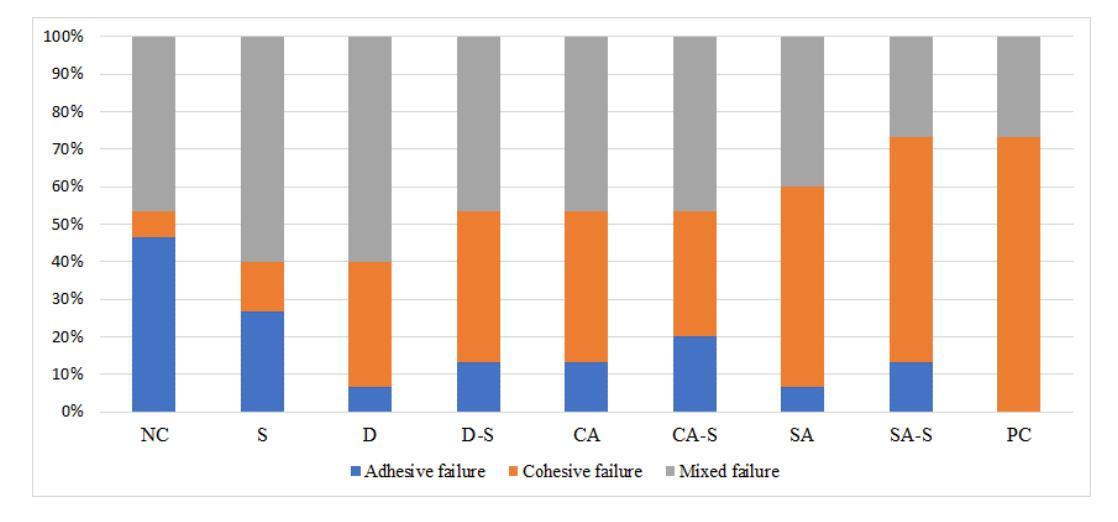
After the shear bond strength test, a stereoscopic microscope was used to examine the debonded surfaces. The distribution of failure modes is illustrated in Figure 4. The group SA-S exhibited the highest rate of cohesive failure (60.0%), followed by 53.3% in group SA. Cohesive failure rates in the other groups ranged from 20.0% to 40.0%. Representative images of the debonded surfaces were observed with SEM at \times 30 magnification (Figure 5).

Figure 4. Distribution of failure mode after shear bond strength test.

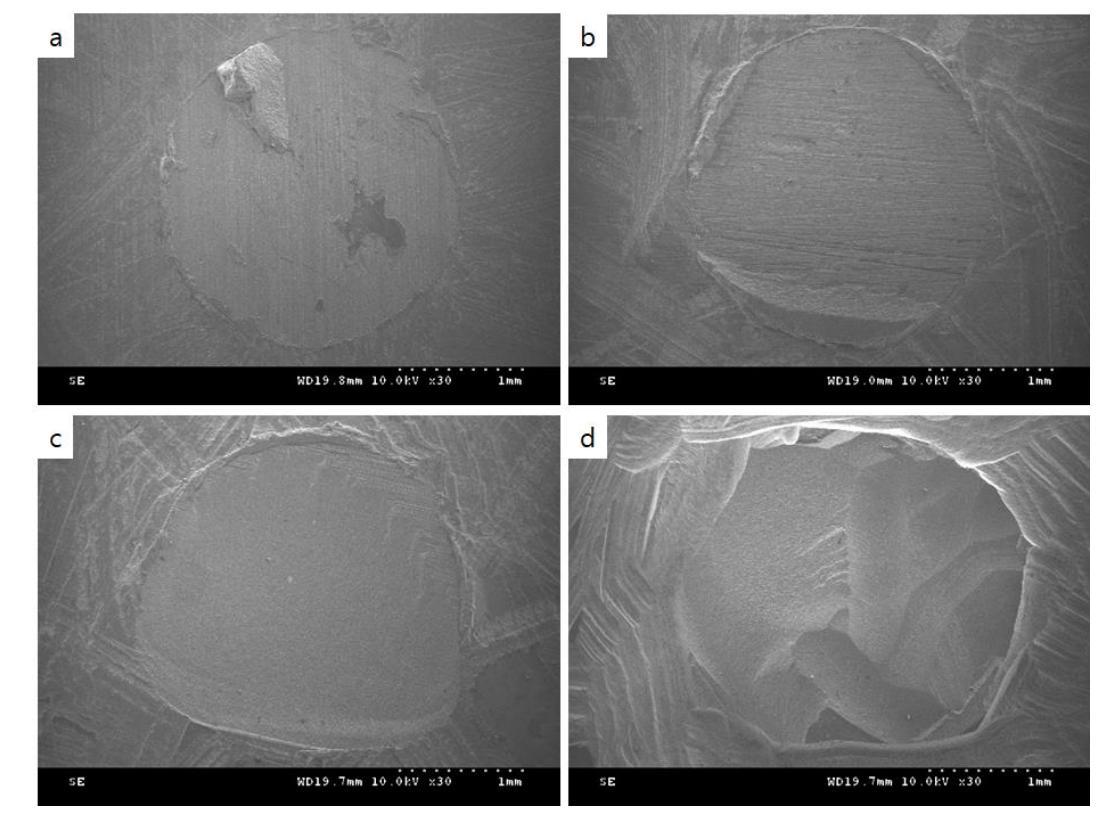
Figure 5. SEM images after shear bond strength test. Representative images of failure surfaces of composite resin using various repair protocols. (a) Adhesive failure in group D. (b) Adhesive failure in group NC. (c) Cohesive failure in Group CA. (d) Mixed failure in group SA.

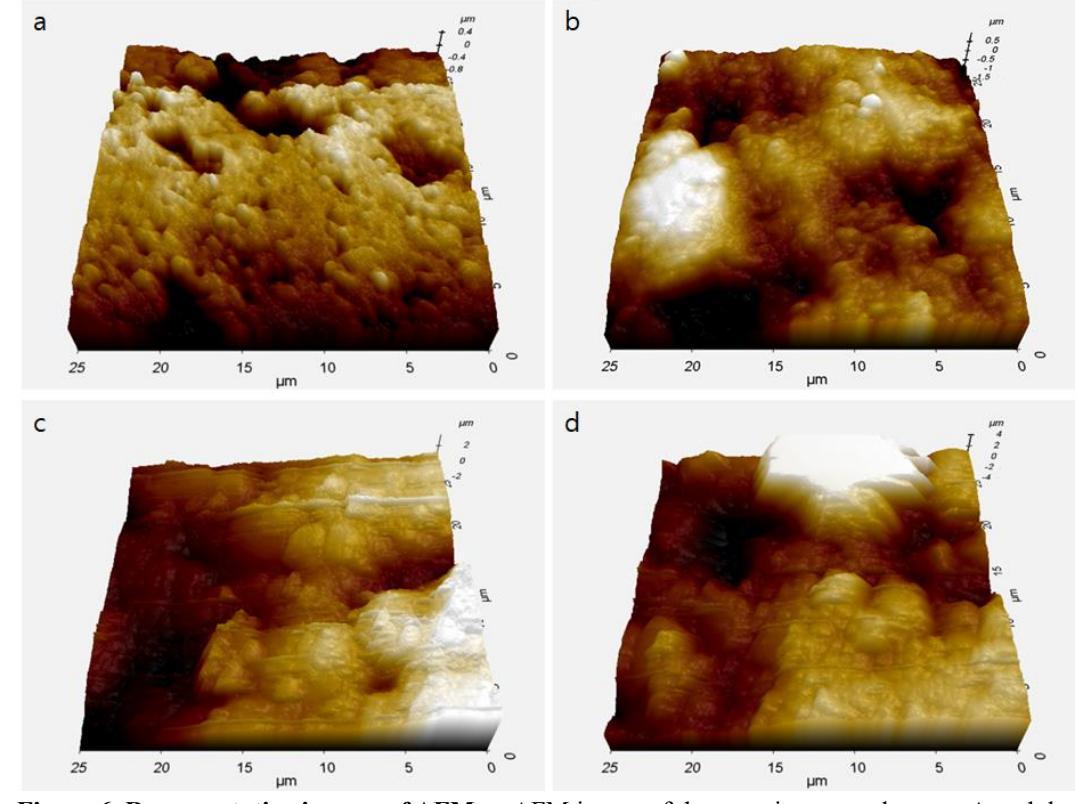
Table 5 presents the mean surface roughness values along with statistical comparisons regarding mechanical surface treatments. A significant difference in surface roughness was found between the sandblast group and both the negative control and carbide bur groups. Although not statistically significant, a slight increase was found in a following order : negative control group, carbide bur group, and diamond bur group. Representative 3D topographies of different mechanically treated groups are illustrated in Figure 6.

Figure 6. Representative images of AFM. a. AFM image of the negative control group. A nodular surface texture can be found on the surface. b. AFM image of the carbide bur group. Ridge and valley are found between nodules. c. AFM image of the diamond bur group. A surface texture similar to Figure. 6b is observed, but with deeper scratches and fewer nodules. d. AFM image of the sandblast group. The scratches are the deepest among all groups.

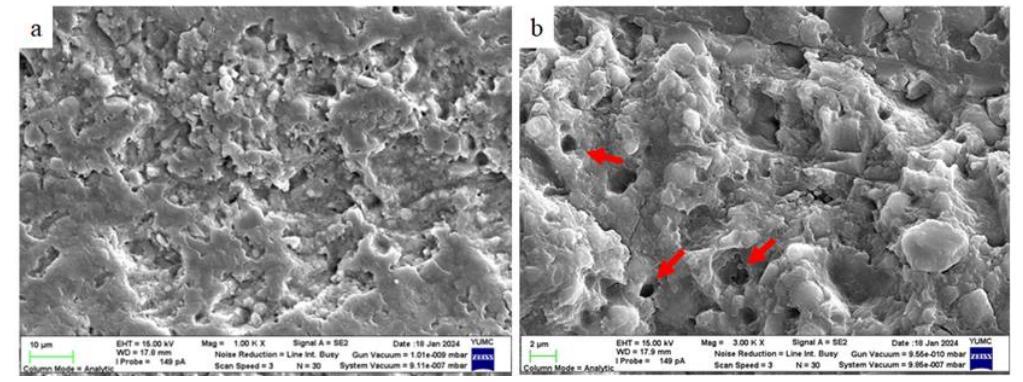
SEM images displaying different surface textures produced by mechanical roughening are presented from Figures 7 to 10. In groups D and CA (Figure 8, 9), scratches, grooves, and a smear layer are observed. Meanwhile, a grit-blasting particles was noted in the sandblasted group (Figure 10).

Figure 7. Representative SEM images of the negative control group observed at x1000 and x3000 magnification. a. x1000 magnification image of the negative control group. Scratches and grooves filled with a smear matrix were detected. b. x3000 magnification of the negative control group. Loss of fillers is observed (red arrow).

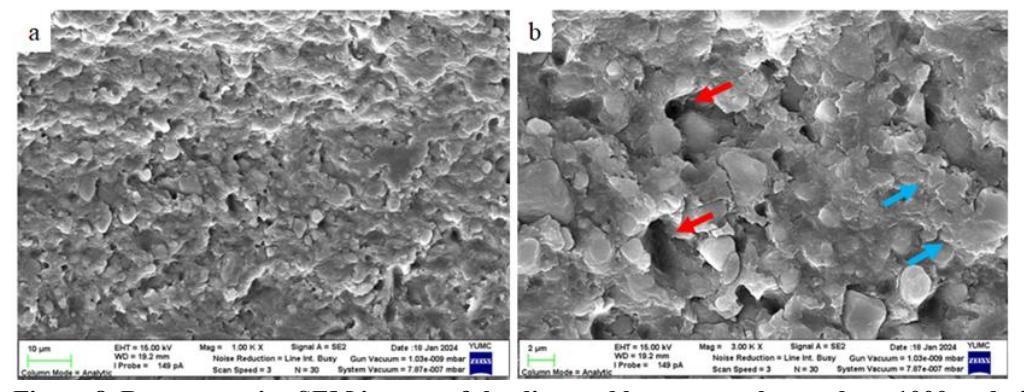
Figure 8. Representative SEM images of the diamond bur group observed at x1000 and x3000 magnification. a. x1000 magnification image of the diamond bur group. Minor topographical alterations in the form of scratches induced by the diamond bur treatment. b. x3000 magnification image of the diamond bur group. Loss of fillers is observed (red arrow), while some smear matrix can be found (blue arrow).

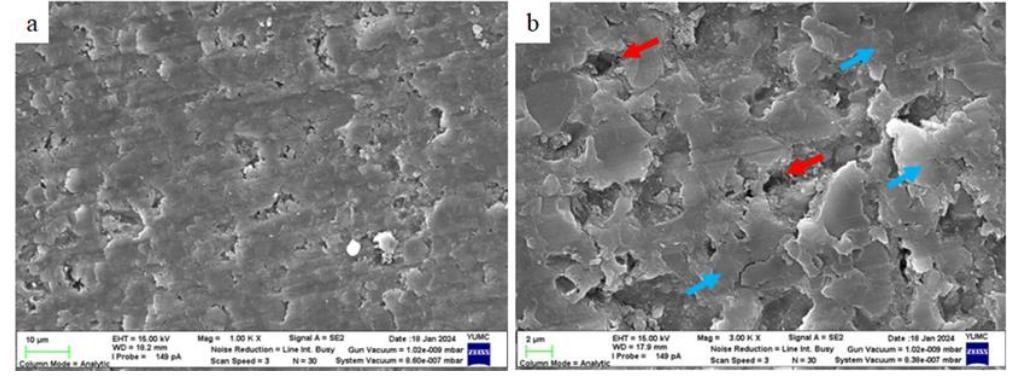
Figure 9. Representative SEM images of the carbide bur group observed at x1000 and x3000 magnification. a. x1000 magnification image of the carbide bur group. A layer of matrix is found on most of the surfaces. b. x3000 magnification image of the carbide bur group. Loss of fillers is observed (red arrow), while a layer of smear matrix can be found (blue arrow).

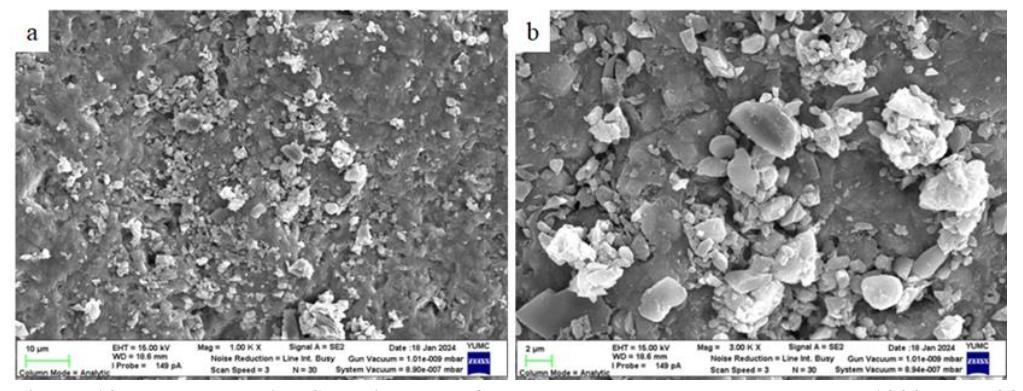
Figure 10. Representative SEM images of the sandblast group observed at x1000 and x3000 magnification. a. x1000 magnification image of the sandblast group. A highly irregular topography was produced, with numerous grit-blasting particles. b. x3000 magnification image of the sandblast group. Aluminum oxide particles are found on the treated surface.

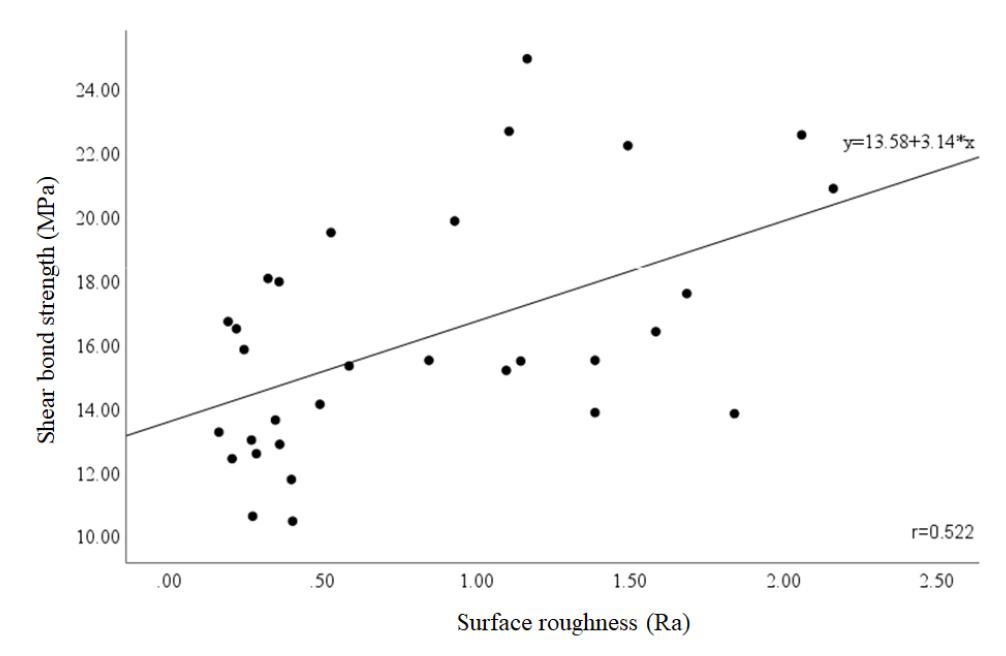
Pearson's correlation analysis was used to determine whether there was a correlation between surface roughness and shear bond strength. A positive correlation was found between two variables (r = 0.522, moderate correlation, p < 0.01).

Figure 11. Correlation between SBS and surface roughness.

A result of AFM showed that sandblasting yields significantly higher roughness values than negative control and carbide bur group. Moreover, a moderate positive correlation between shear bond strength and surface roughness was observed (p = .003; r = 0.522).
